Residential Property Inspection Report

Property Address: **8827 Big Bend Drive**
Any City NC 28123

FILE #: 050203bar.
DATE OF INSPECTION: March 2, 2005.
CLIENT NAME: Jim Smith.
INSPECTION SITE: 8342 Big Bend Drive.
INSPECTION SITE CITY/STATE/ZIP: Any City, NC 28123.

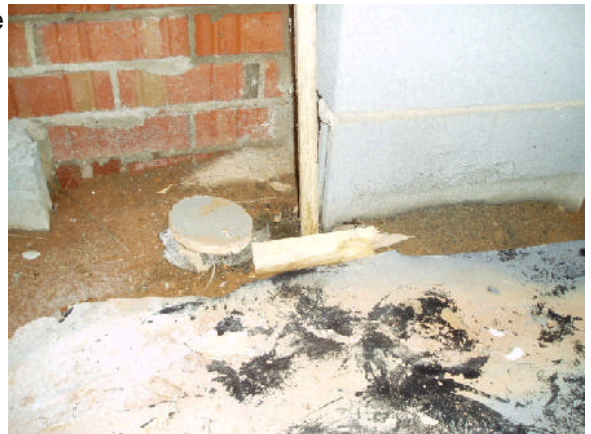
OTHER OBSERVATIONS: Wood debris in the crawl space is in contact with the soil. This condition is conducive to wood destroying insects. Recommend removing all wood debris from the crawl space.

Wood debris in the crawl space is in contact with the soil. This condition is conducive to wood destroying insects. Recommend removing all wood debris from the crawl space.

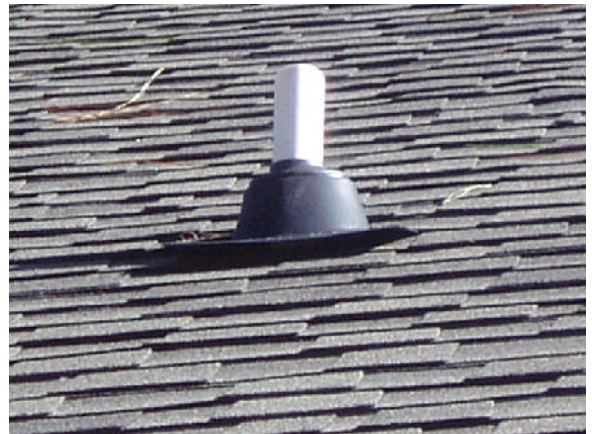
CONDITION: Several of the exterior roof penetration flashings have pulled up from the roof. Recommend re-securing the flashings and sealing all exposed fasteners. Recommend all repairs be made by a qualified Roofing Contractor.

Several of the exterior roof penetration flashings have pulled up from the roof. Recommend re-securing the flashings and sealing all exposed fasteners. Recommend all repairs be made by a qualified Roofing Contractor.

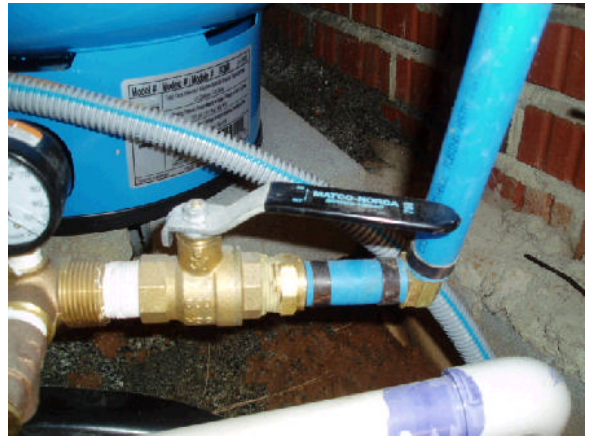
MATERIAL: Plastic.
CONDITION: The main line is functioning as intended. The main plumbing shut off valve is located in the crawl space.

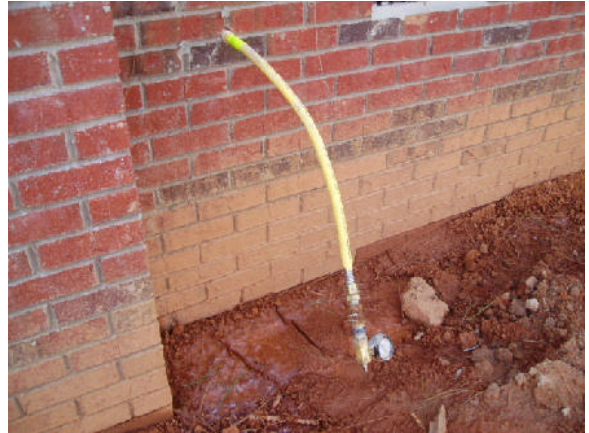
There is a gas line at the right exterior of the home. No gas meter or LPG tank was connected to the line at the time of inspection.

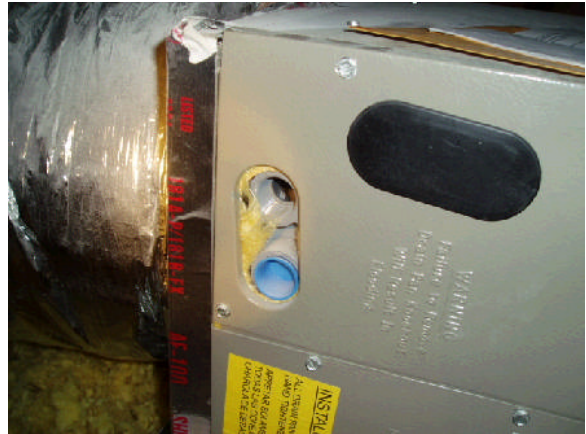
PRIMARY UNIT: Both units are functioning as intended.
PUMP/BLOWER FAN: Functioning as intended.
AIR PLENUM: One of the plugs in the sheet metal at the evaporator coils, on the unit in the attic, is missing. This condition allows conditioned air to escape from the plenum. Recommend re-plugging the hole.

One of the plugs in the sheet metal at the evaporator coils, on the unit in the attic, is missing. This condition allows conditioned air to escape from the plenum. Recommend re-plugging the hole.

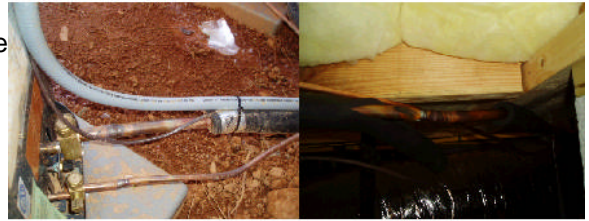
The insulation on the HVAC low pressure refrigerant line(s) is damaged on the unit(s) in the attic, in the crawl space, and at the exterior. Recommend repairing/replacing the damaged insulation.

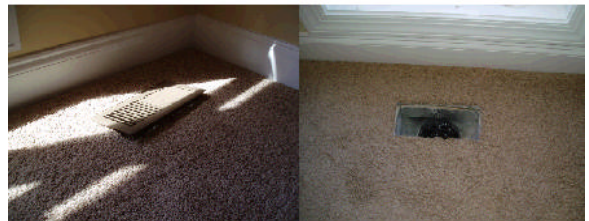
One of the floor registers in the master bedroom did not fit properly and one in the master bedroom closet is missing. Recommend properly installing the floor vents.

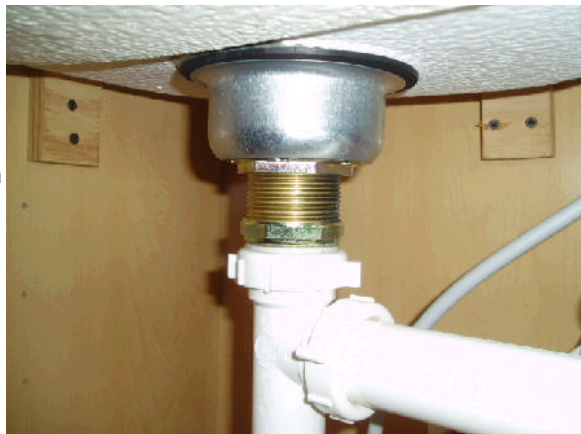
The sink components including the hand sprayer are functioning as intended. The following problem(s) were noted at the sink drain: Leakage was noted at the drain pipes under the left hand bowl. Recommend repairs be made as needed to stop leakage.

The following problem(s) were noted at the sink drain: Leakage was noted at the drain pipes under the left hand bowl. Recommend repairs be made as needed to stop leakage.

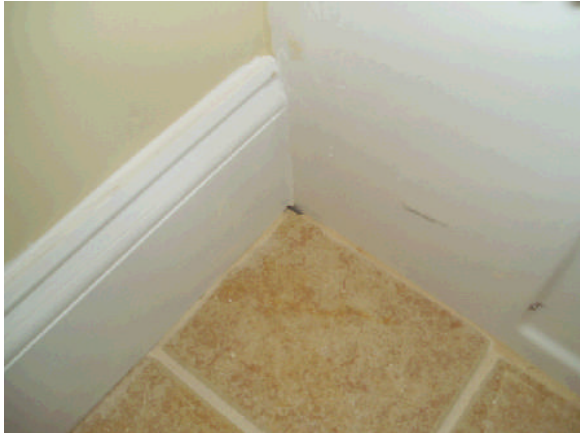
TUB/SHOWER AND WALLS: Caulking and/or re-grouting is needed at the floor to enclosure interface to prevent moisture intrusion.

Caulking and/or re-grouting is needed at the floor to enclosure interface to prevent moisture intrusion.

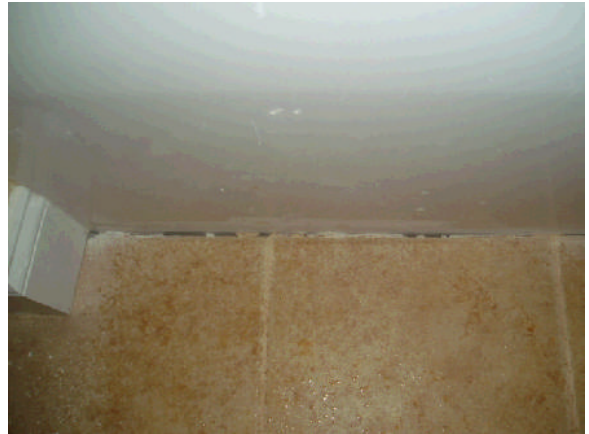
Caulking and/or re-grouting is needed at the floor to enclosure interface to prevent water intrusion.
