Residential Property Inspection Report

Property Address: 1 My Street
Any Town, NC 00012

FILE #: 100525one.
DATE OF INSPECTION: 5-25-2010.
CLIENT NAME: Jack & Jill Hill.
INSPECTION SITE: My Street.
INSPECTION SITE CITY/STATE/ZIP: Any Town, NC 00012.

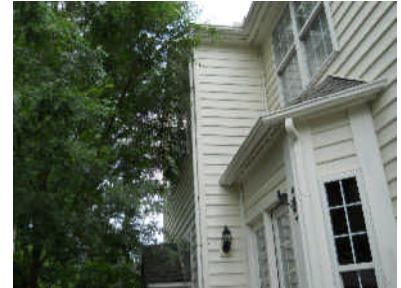
CONDITION: Tree limbs are touching or overhanging the roof and siding. Damage to the roof covering and structure is possible. Recommend limbs be removed by a qualified tree removal service.

1. Tree limbs are touching or overhanging the roof and siding. Damage to the roof covering and structure is possible. Recommend limbs be removed by a qualified tree removal service.

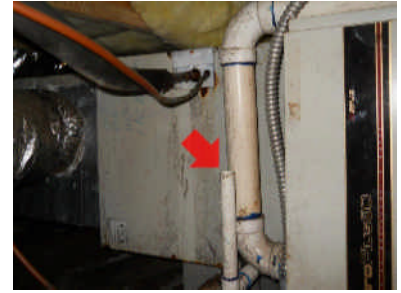
A condensate line is installed at the evaporator coils. The trap clean-out cap is missing. Without a cap the trap is defeated. Recommend replacing the missing cap.

10. The trap clean-out cap is missing. Without a cap the trap is defeated. Recommend replacing the missing cap.

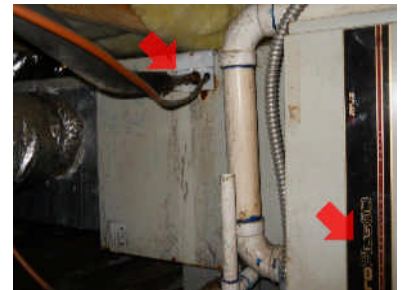
The insulation on the HVAC low pressure refrigerant line stops short of the sheet metal on the unit in the crawlspace. This condition will allow condensation to drip onto the main air handler cabinet and cause premature rusting of the unit. Recommend the low pressure refrigerant insulation be run all the way to and be flush with the sheet metal on the main air handler.

11. The insulation on the HVAC low pressure refrigerant line stops short of the sheet metal on the unit in the crawlspace. This condition will allow condensation to drip onto the main air handler cabinet and cause premature rusting of the unit. Recommend the low pressure refrigerant insulation be run all the way to and be flush with the sheet metal on the main air handler.

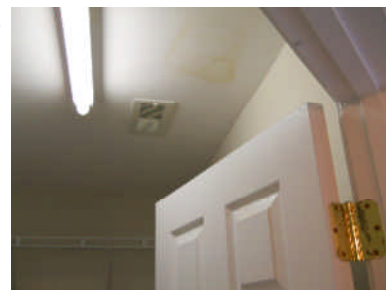
TYPE & CONDITION: The ceilings are covered with Drywall. Moisture stains were noted on the ceiling in the master bedroom closet. Stains are due to roof plumbing boot leaks.

19. Moisture stains were noted on the ceiling in the master bedroom closet. Stains are due to roof plumbing boot leaks.

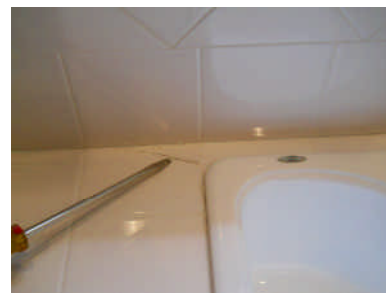
COUNTERS AND CABINETS: Cabinets are wood. Cabinets are functioning as intended. Counters are tile. Tile is cracked at the left rear corner of the sink. Recommend replacement of the cracked tile to prevent moisture damage to the wood sub surface.

21. Tile is cracked at the left rear corner of the sink. Recommend replacement of the cracked tile to prevent moisture damage to the wood sub surface.
